# ON-SITE REPAIR OF FEEDSTOCK OVEN'S DRIVE SHAFT

## Customer's Challenge

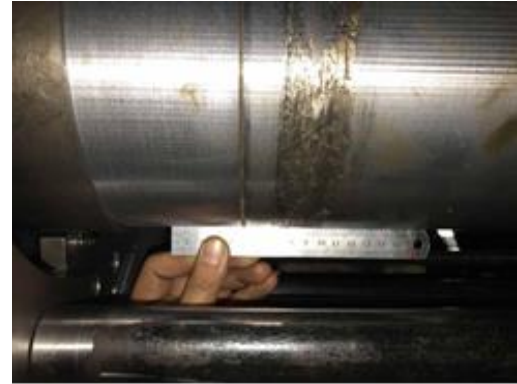
A feedstock process company located in Singapore, had encountered a badly worn off drive shaft on one of its key production ovens. The shaft is driven by a motor and supported by a bearing. The area where the bearing in contact with the shaft, is constantly subjected to abrasive due to the rotation and causes significant wear and tear over a period of time (illustrated in the photo). Shutting down the problematic oven for repair means reduce in the process plant's productivity; the duration for the shaft's repair has become very essential.

Damaged Shaft

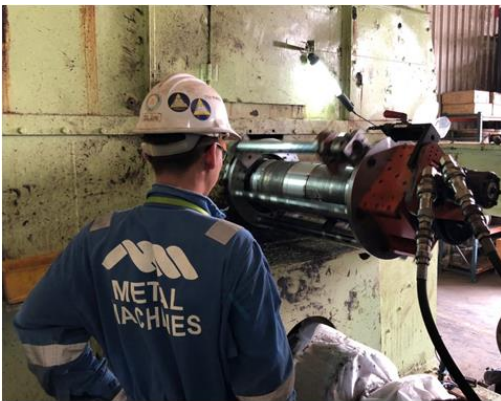
Machining of the rotor shaft

After a discussion at site with the client's representatives, Metal Machines offered to restore the drive shaft by conducting in situ machining to reduce shaft's diameter and inserting a new sleeve to match the bearing.

The drive shaft was machined into the required size while the new sleeve was machined in Metal Machine's workshop with sufficient inner diameter interference and shrink fit into the shaft without the need for final machining.

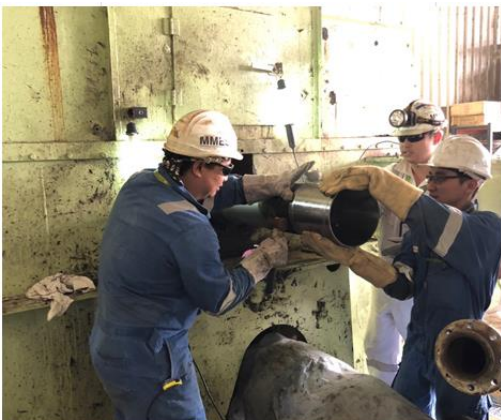
Installing of sleeve
