## ON-SITE MACHINING OF JETTY CRANE FOUNDATIONS

### Customer's Challenge

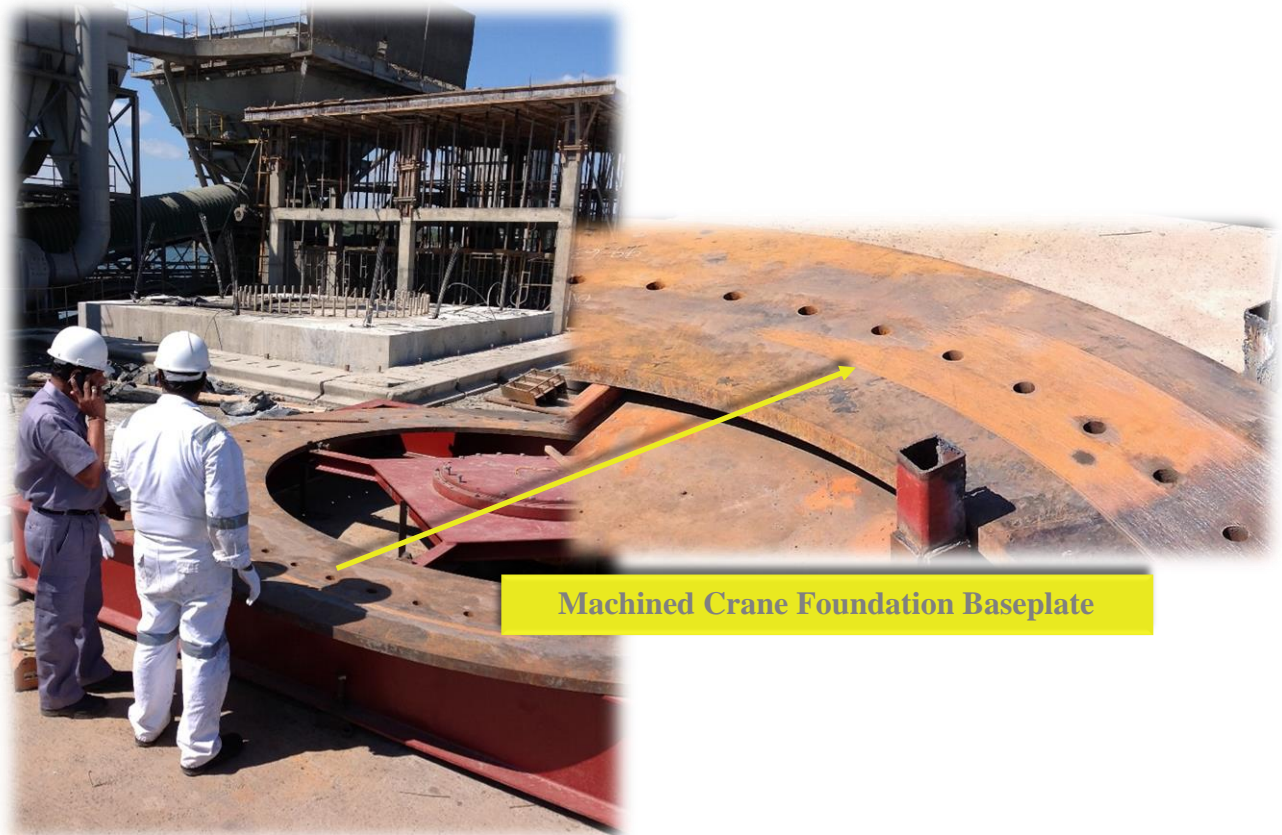
A client located in Sri Lanka initially engaged a local in-situ service provider to conduct machining on 3 jetty cranes' foundation baseplates; after several attempts, the service provider is still unable to fulfil the crane manufacturer's required specification.

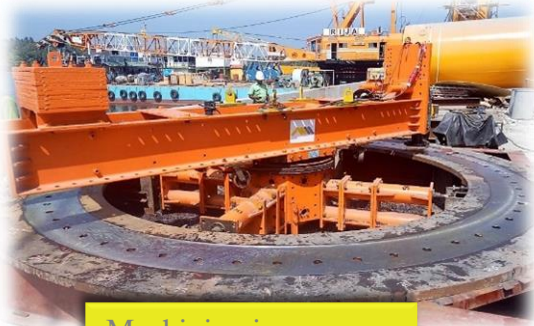
Machining in progress

Equipped with vast experiences in rendering in-situ machining and structural alignment for crane's key components (crane foundation, crane pedestal and crane boom), our sales representative was able to analyse and advice the client the necessary solutions with the expected timeline to remedy the whole situation. Upon received notification from Sri Lanka, the Singapore team started the preparation of the customised circular milling machine to be shipped out on the next available freight slot to site. Metal Machines mobilise a team of 2 field service specialist to complete the recovering mission within 10 days.

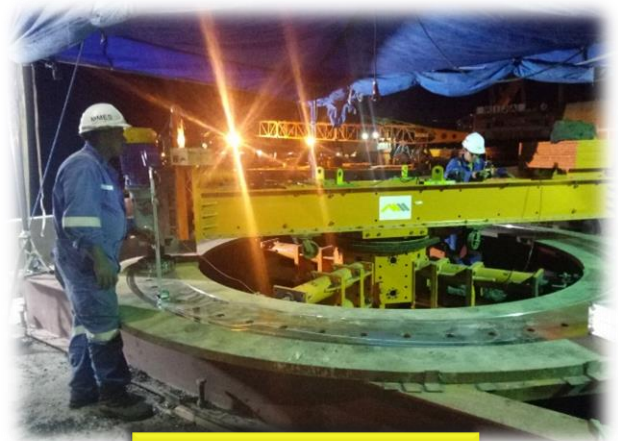
Post Machining Survey

The site team readjusted the first baseplate with some improvise jacking pieces at site to achieve the requirement without compromise thickness requirement. All the 3 baseplates are machined within 0.1mm surface flatness runout.

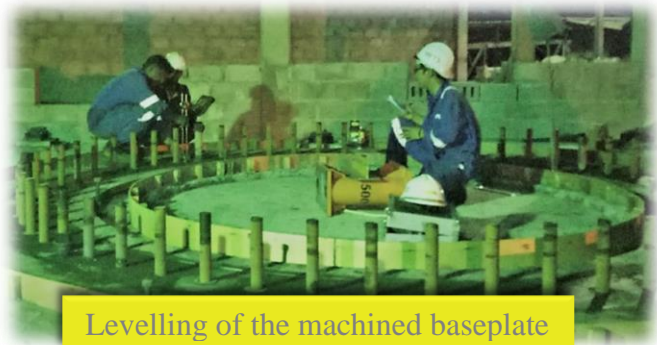
Levelling of the machined baseplate

**To ensure that cranes are installed without implication that may jeopardize the commissioning deadline,** The site team put in extra mile by assisted the client in levelling the baseplates to the crane foundations.

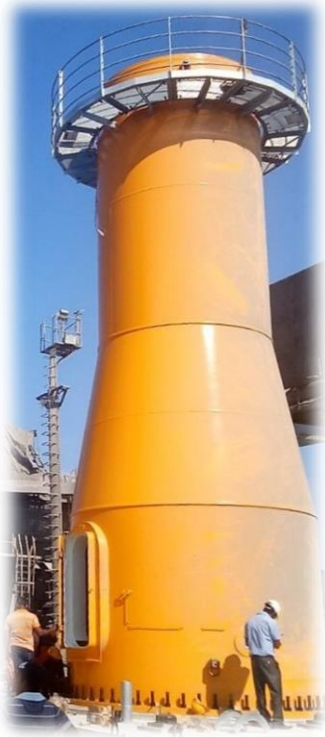
Metal Machines' customizable in-situ circular milling machines is able to accommodate crane pedestal and round foundation ranging from 2 to 6 metres in diameter which allow a single machine to tackle different size of job on same location as compared to other off the shelf circular milling machines in the market. Such versatility helps to improve response time as lesser machines are needed for preparation.
